Technical Service Bulletin

MODEL(S) AFFECTED: **T3/T3+ Models with Propel**

SUBJECT: False Battery Discharge Indicator reading. If BDI charge level rapidly drops upon machine start up, the control board module may have a program error.
Note: The actual run time is not affected by false BDI reading, the batteries will continue to discharge as normal.

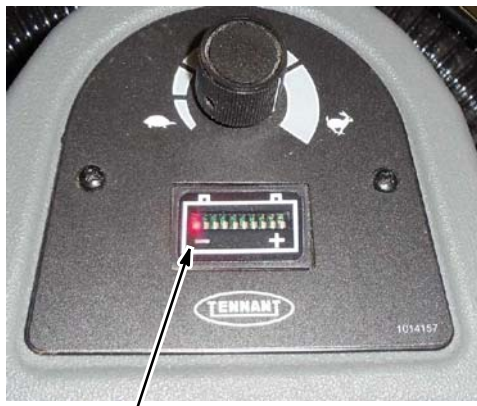
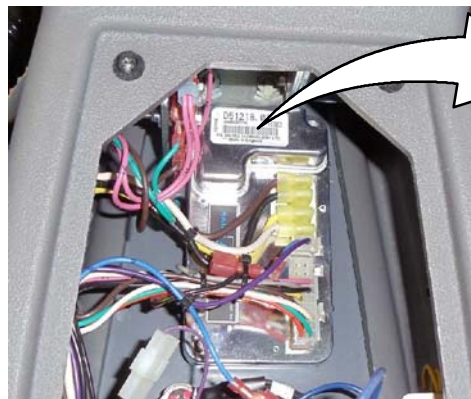
False BDI reading when batteries are fully charged. The actual run time is not affected by the false reading, the batteries will continue to discharge as normal.

Replace control board module with Revision 03.

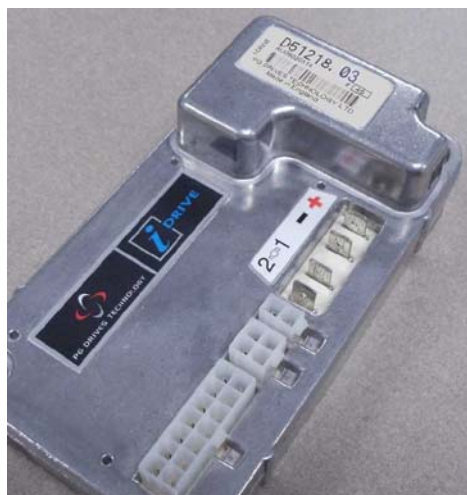
Replacement Control Board Module Rev. 03 (p/n 1052260).

Note: The new module revision level 03 may be hand-written due to existing inventory was reprogrammed.
