Technical Service Bulletin

MODEL(S) AFFECTED: Speed Scrub 500 Walk-Behind Scrubber

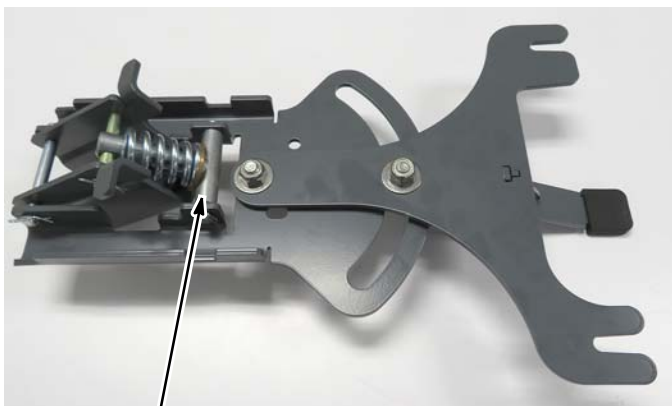
Squeegee Lift Bracket Spring Guide

SUBJECT: The bronze spacer located on the squeegee lift bracket spring guide may fail during normal operation over time. If spacer fails (cracks in half), the squeegee blade pressure that is applied to the floor will weaken and cause a reduction in solution pickup. The squeegee pedal may also fail to stay in the up position during transport due a failed spacer.

PURPOSE: To repair or prevent the above issue, order the Squeegee Bracket Spring Guide Kit 9016898. The new spring guide is designed to be used without a spacer.

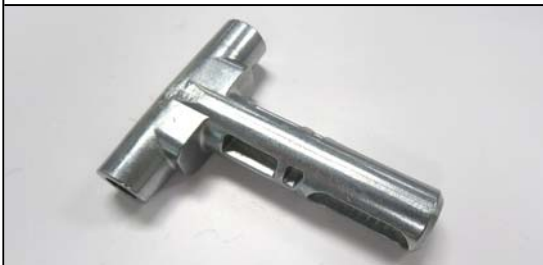
9016898 Squeegee Bracket Spring Guide Kit Contents

1235860 Spring Guide (no spacer required)
9016897 Installation Instructions

Kit Installation Note: The squeegee lift bracket must be removed from the machine in order to relieve tension on spring for spring guide removal. Follow the installation instructions supplied with kit.

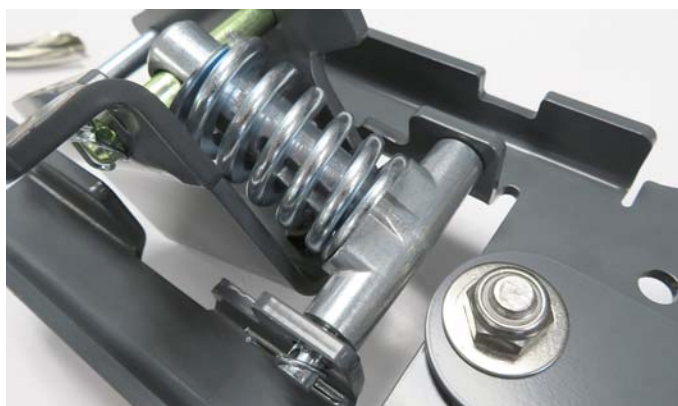
Manufacturing Note: As an interim upgrade prior to implementing the new spring guide into production, two stainless steel washers that equal the same thickness of the bronze spacer (to maintain the proper spring retention) were used as a replacement.
