Technical Service Bulletin

MODEL(S) AFFECTED: i-mop XL PLUS model part number 1251236 (manufactured before s/n 331538 or P300964)
i-mop XXL PLUS model part number 1251235 (manufactured before s/n 630163 or P600163)

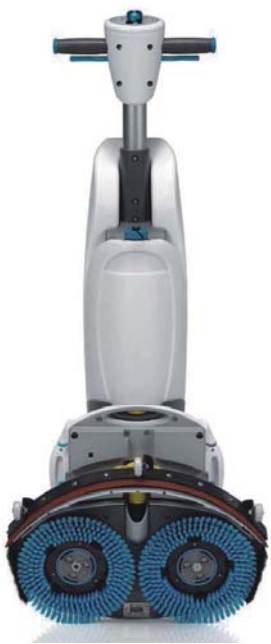
Park position

SUBJECT: The machine is designed with a park position shut-off switch to prevent battery discharge when not in use. There's been a couple reports that when the machine is in the park position, the control panel begins to beep and light up intermittently. The reason, we've discovered that some PCB boards (1:60) may be affected by a magnetic disturbance causing the metal ball within the tilt switch to not function properly.

PURPOSE: To repair the above issue, order replacement PCB board p/n 1251756. In the meantime, it's recommended to remove batteries during machine storage.
