TECHNICAL SERVICE BULLETIN

980355-007

TITLE:
REAR WHEEL TO HUB INTERFERENCE

APPLICABLE MACHINES:
355, 385

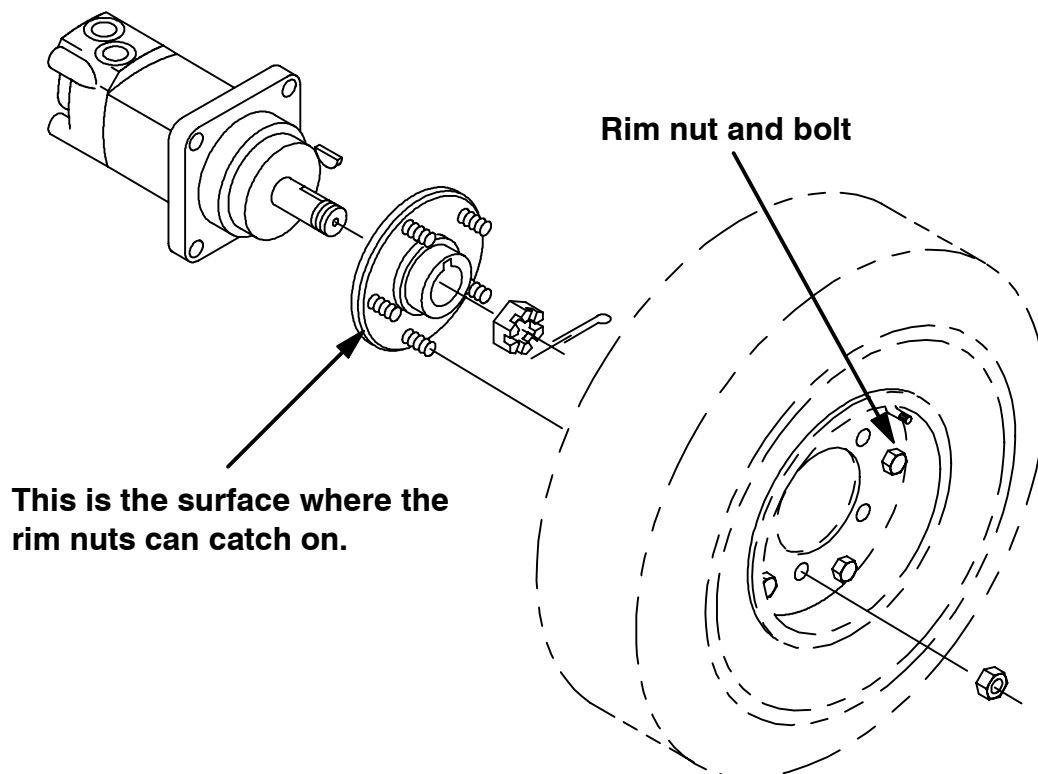
SYNOPSIS:
The rim is not sitting flush onto the hub assembly.

There are five nuts and bolts that hold the rims together on all 355 and 385 machines. Once these nuts are tightened down, the rim is then installed onto the hub. There have been some cases where the rim was hanging up on the hub and it was discovered that there is very little clearance between the hub and the rim nuts. If the flats of the nuts are not positioned in a certain way, they will get hung-up on the hub. The rim will not sit flush onto the hub and soon the holes in the rim will tear out or the studs will break.

The only way to verify this is to take off the wheel and lay it face down on the ground. Remove the hub from the motor and place it onto the back of the wheel. You will now see if any of the rim nuts are turned in such a way that the hub does fit completely flush onto the surface of the wheel. Rotate any of the nuts if necessary. Refer to Fig. 1 for assistance. **After reassembly, re-torque the hub nut to 200–250 ft. lbs. and the lug nuts to 85–95 ft. lbs.**
