TECHNICAL SERVICE BULLETIN 980530-008

TITLE:
REAR SQUEEGEE

APPLICABLE MACHINES:
530E

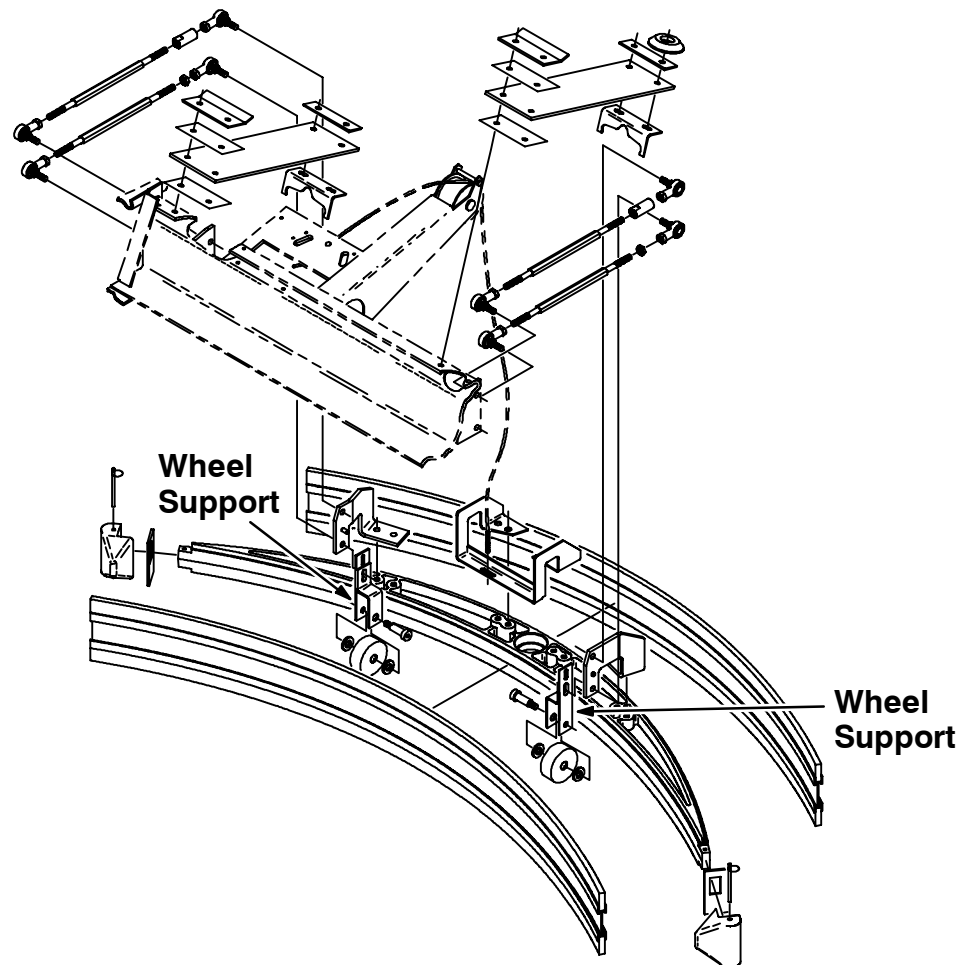
REAR SQUEEGEE WHEEL SUPPORT

If the rear squeegee cannot be adjusted for the correct deflection, check the wheel supports. Proper adjustment of rear squeegee is not possible if either, or both of the wheel supports are bent. Wheel support, Tennant Company part number 86805, has been strengthened to prevent the chance of bending. The new wheel support is now in production.
