TECHNICAL SERVICE BULLETIN 98800-017

FRONT BUMPER REWORK- SIDE BRUSH MOTOR CLEARANCE

800,810 Model 800 machines below serial number 1184 and 810 machines below serial number 2066.

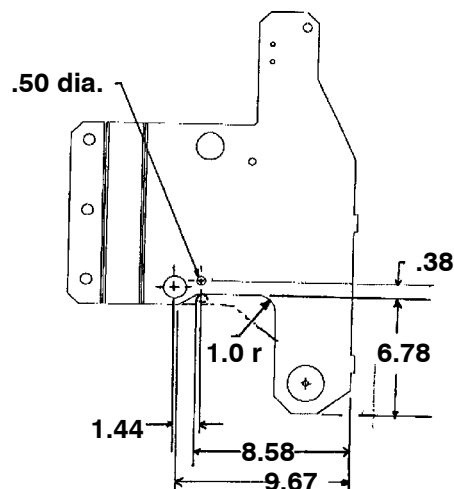
The bumper gusset on the side of machine could possibly interfere with top side of side brush motor when side brush is in the up position and off.

1. The inside gusset that mounts to the hopper interferes with the side brush motor when the motor is in the up position and gets hit on the guard and pushed under the machine.
 2. This problem only happens when the side brush is up. In the down position and sweeping there is enough clearance.
 3. To solve this problem, lift and roll out hopper.
 4. Remove bumper or SE towers if equipped, to get access to gusset to be reworked. The old style bumper #63632 has to be reworked on the machine because of the way it was designed.
 5. Cut gusset as shown in sketch below.
 6. Redrill 1/2" dia. hole as shown to mount dump door pivot pin retainer.
 7. Repeat steps 4, 5, and 6 if the machine is equipped with a left hand side brush opt.
- IMPORTANT -** When cutting gusset, make sure the hyd. cylinder and hoses are protected from cutting sparks.
