TECHNICAL SERVICE BULLETIN

No. 98800-020 Rev.1
Machine: 800/810
System: CHASSIS

STEERING CYLINDER MOUNT BRACKET

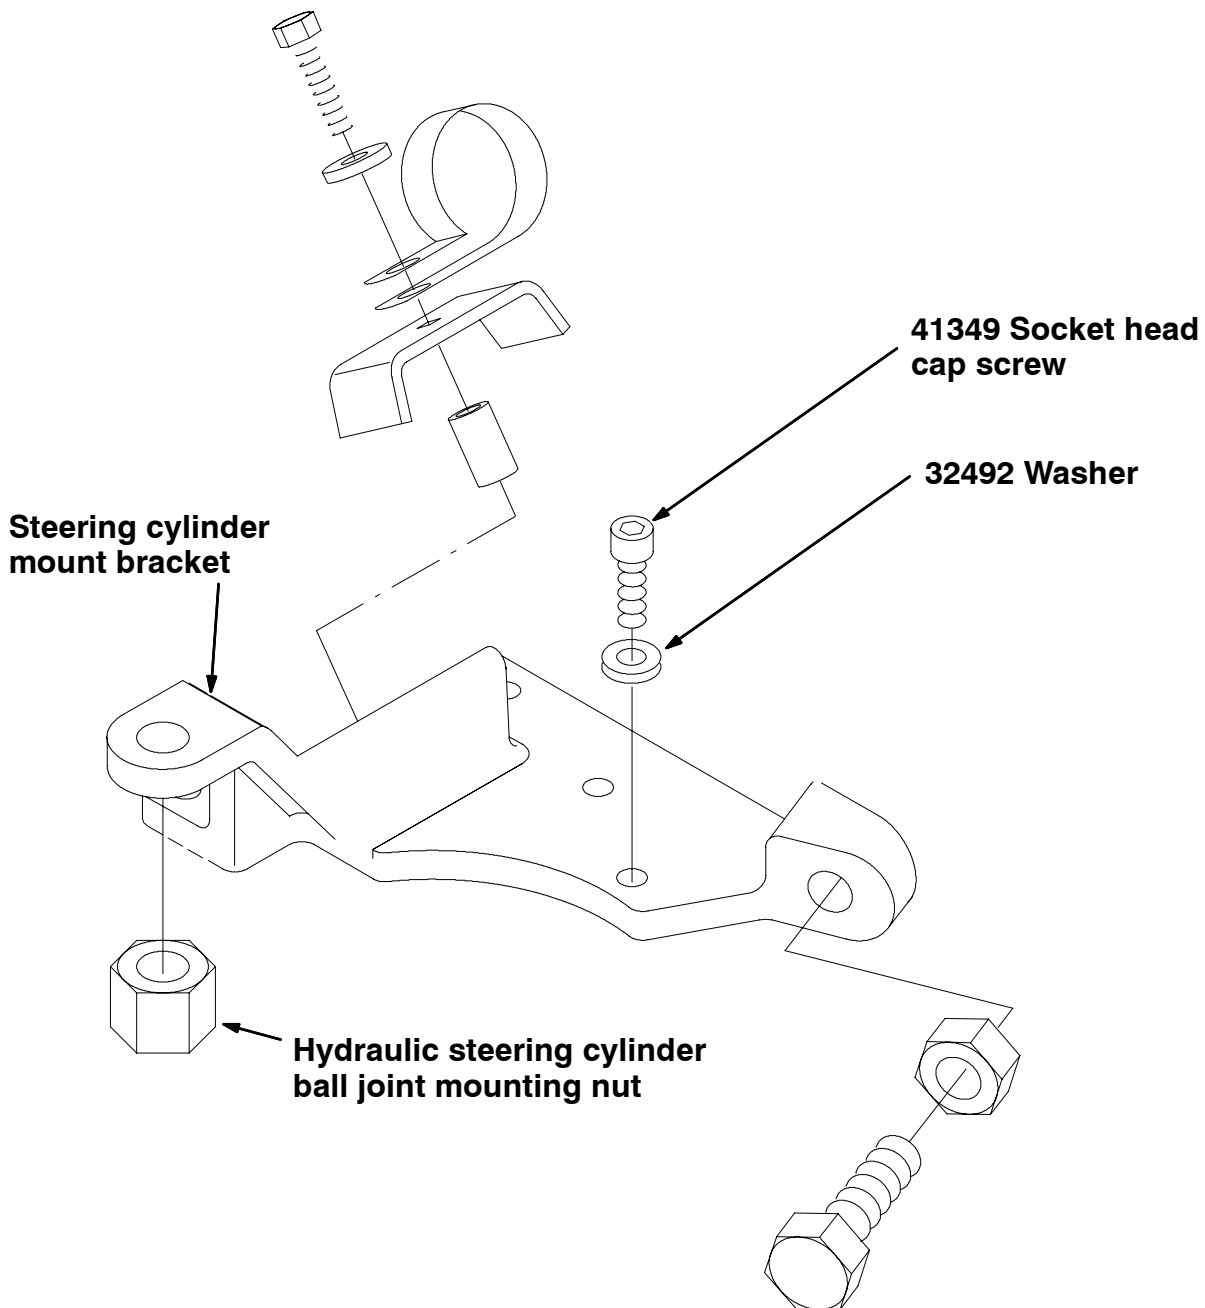
FIG. 1 - Steering Cylinder Bracket

The 800/810 steering cylinder mount brackets and rear wheel support are subjected to severe centrifugal forces when a machine makes a u-turn. Be sure to inspect all hardware for the steering bracket and rear wheel support when performing maintenance on a machine. Be sure to check for loose or damaged components. The machine could possibly have the wrong hardware or the improper torque on the screws that mount the steering cylinder bracket to the rear drive support casting.

1. Raise the seat.
2. Locate the steering cylinder mount bracket on the top of the rear drive casting.
(Refer to Fig. 1)
3. Check the hardware attaching the bracket to the casting. This hardware should be **SOCKET HEAD CAP SCREWS** (part # 41349), M10-1.5x30mm long with 3/8 **flat washers**, (part # 32492). If any other type of hardware is installed, remove and discard.
(Refer to Fig. 1)
4. On some machines the tapped holes may have dirt and shavings trapped in the holes. This debris can prevent proper engagement of the hardware.
5. The proper depth of the threaded hole should be 7/8 inch. Use a small ruler or scale to check this.

The hardware that mounts the steering cylinder bracket to the rear drive casting may have to be replaced and re-torqued. Please follow the procedure instructions if needed.

6. Any debris must be thoroughly cleaned out of the tapped holes.
7. Apply red locktite 271 (part # 19857) to the tapped holes and install the socket head cap screws. The proper torque is 46-60 ft lb (63-81 Nm). (Refer to Fig. 1)
8. Check the hydraulic steering cylinder ball joint mounting nuts for proper torque. The torque should be 215-280 ft lb (290-380 Nm).
