# Technical Service Bulletin

**MODEL(S)  
AFFECTED:**
**Tennant 1510 Automatic Carpet Extractor**

(Models manufactured before Serial Number 90050-10311505 DC1206)

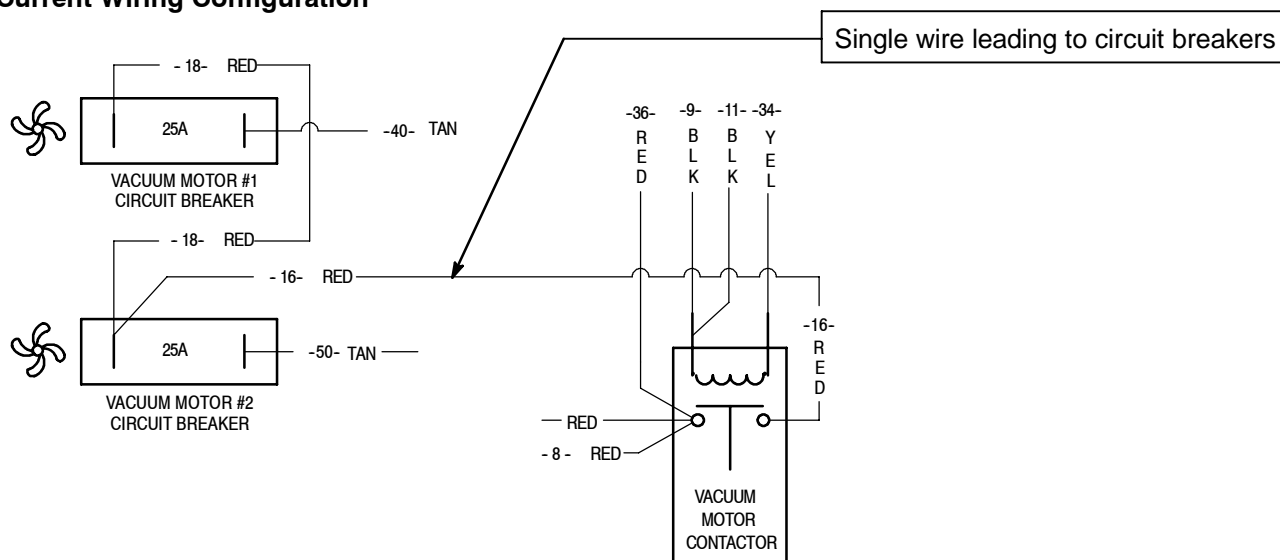
**Current Wiring Configuration**

Reports have been received that the wire leading to the vacuum motor circuit breakers may be underrated and may result in frequent tripping and/or minor wire damage.
