Technical Service Bulletin

MODEL(S) AFFECTED: **T7 Rider Scrubber** - Models manufactured before serial number 10613731 (April 9, 2013).
Models manufactured in Europe before serial number T7xxx06952 (April, 2013).

SUBJECT: Potential drain hose damage due to careless machine operation when transporting with squeegee raised. If the right side of the squeegee assembly strikes a wall or obstruction with excessive force (see photos below), the left edge of the squeegee lift bracket will crush the drain hose causing damage and water leakage.

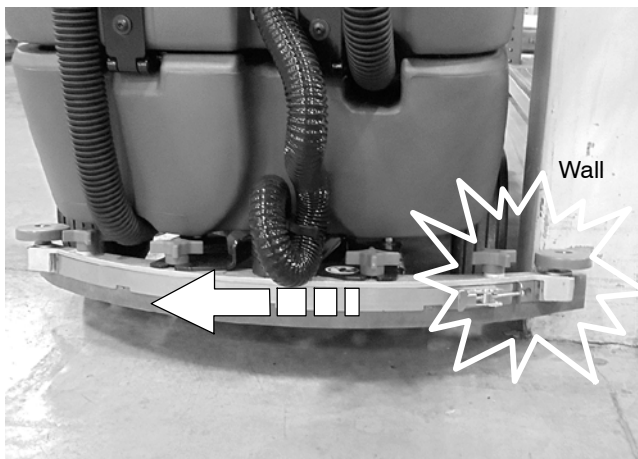
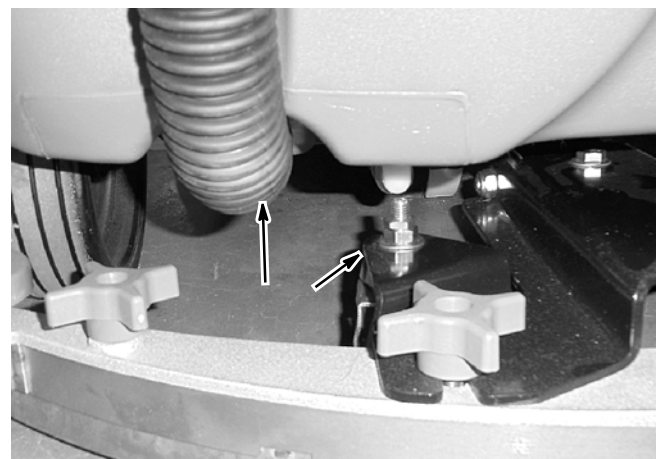
When squeegee assembly strikes a wall with excessive force, the left side of the squeegee lift bracket will crush drain hose.
