# Technical Service Bulletin

**MODEL(S)  
AFFECTED:** **M17**

**SUBJECT:** Vacuum fan(s) turning off after a few minutes of operation. Error code 520 (static discharge interfering with vacuum fan operation) appears in the display when the vacuum fan(s) stop operating.

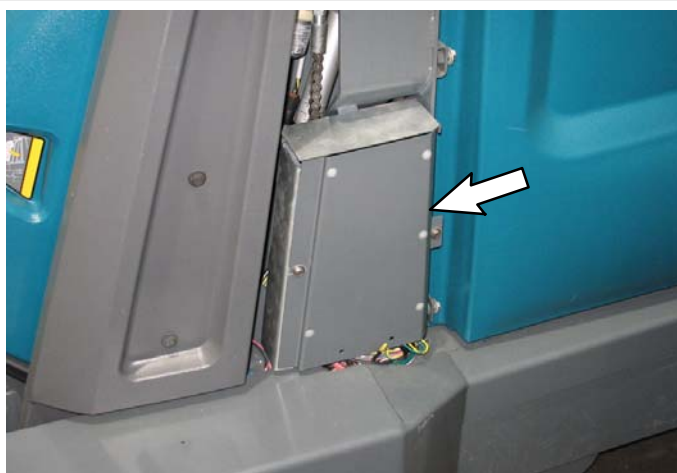
FIG. 1 - Sweep Circuit Board Located Inside Electrical Enclosure On Electrical Enclosure Cover

1. Check sweep board revision number. The sweep board should be labeled revision 01. Machines above serial number M17- 10293 already have this circuit board installed. Replace sweep board if it is labeled revision 00 (machines serial numbers below M17- 10293). (Fig. 1 / Fig. 2)  
If a new Sweep Board is required, order Circuit Board Kit, Swp, Side, Afmkt [M17] - Kit Number 9015048. The IB for this kit is IB 9015110.
2. Use Service Diagnostic Tool to check software revision. If necessary, update to latest software revision.
3. Check if vacuum fan static harness / fan guard are installed. Machines above serial number M17- 10271 already have the vacuum fan static harness / fan guard installed. Install vacuum fan static harness kit onto machines serial numbers below M17- 10271. (Fig. 3)

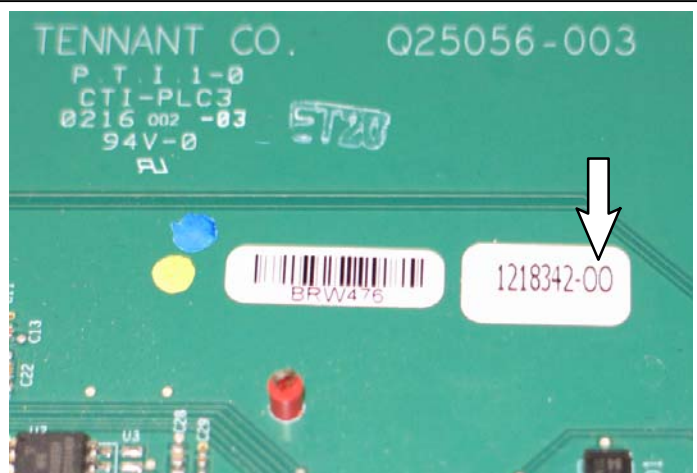
FIG. 2 - Sweep Circuit Board Revision Number Location

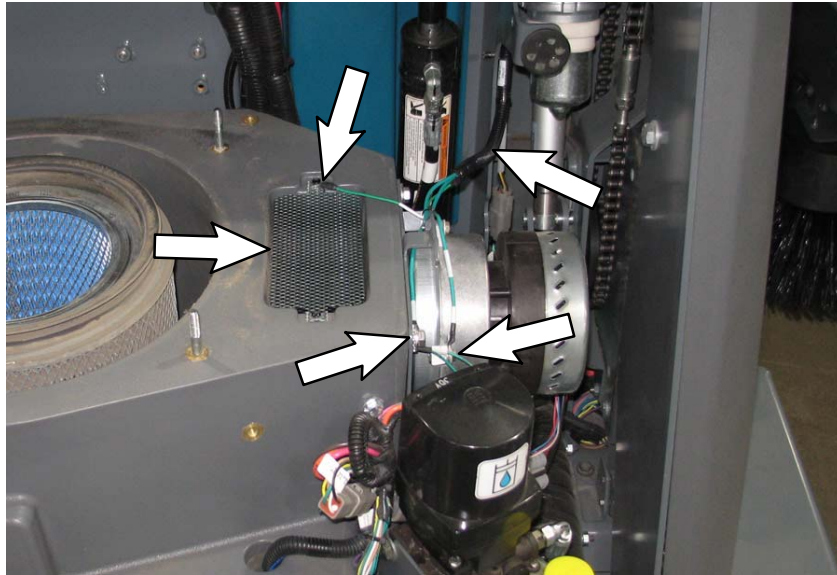
*Note: Machines serial numbers M17- 10240 through M17- 10271 may have an incorrectly installed static harness. If this harness is installed, and is not connected directly to a thread roller in the frame (connected to the hopper down switch bracket instead), it should be replaced.*

FIG. 3 - Harness, Ele [Static Gnd, M17] / Plate, Fan, Guard

If a vacuum fan static harness / fan guard are required, order Harness Kit, Vac Fan, Afmkt [Static Ground] - Kit Number 9015386. The IB for this kit is IB ~~9015386~~ **9015268**
