TECHNICAL SERVICE BULLETIN 980530-007

FRONT WHEEL DRIVE GEARBOX

530E

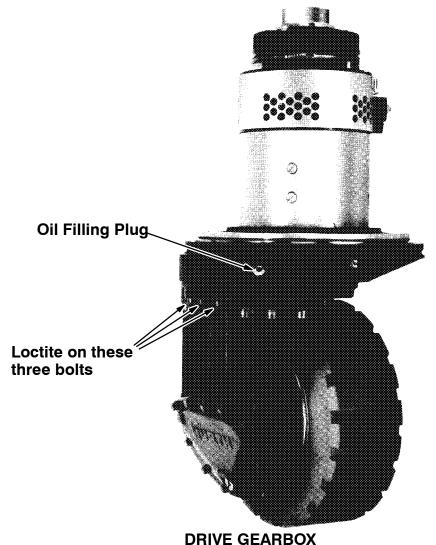
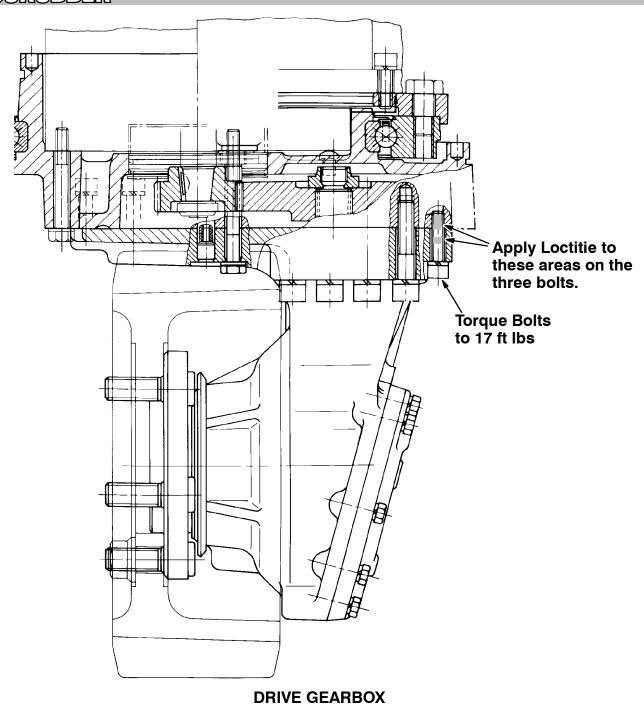
The front wheel drive gearbox might leak after only a few hours of operation.

To stop the leaking, first check the fluid level and drain any excess fluid. Then remove the 3 bolts located below the oil filling hole. Clean and apply Loctite #515 or #242 and torque to 17 ft lbs. Use 90 wt gear lube, capacity is 2.7 liters.
