# Technical Service Bulletin

**MODEL(S) AFFECTED:** **Tennant S20 Electric Machines (serial numbers 000000-001070)**

**SUBJECT:** Clogged filter light not operating (to alert operator that the filter is clogged and needs to be shaken) due to the vacuum hoses from the cyclone cover and filter cover connected to the wrong ports on the pressure switch.

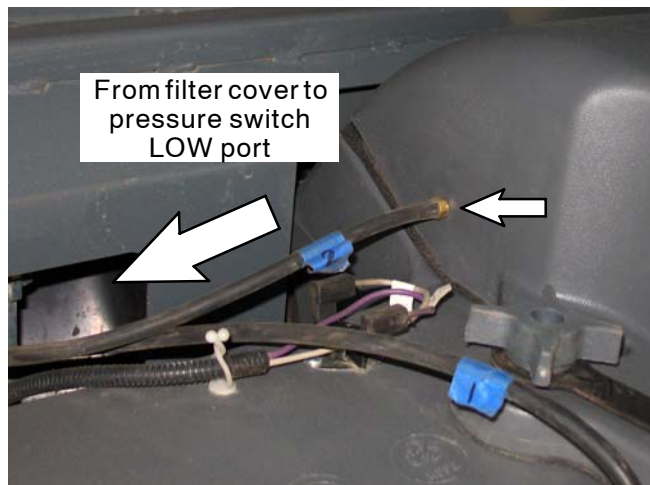
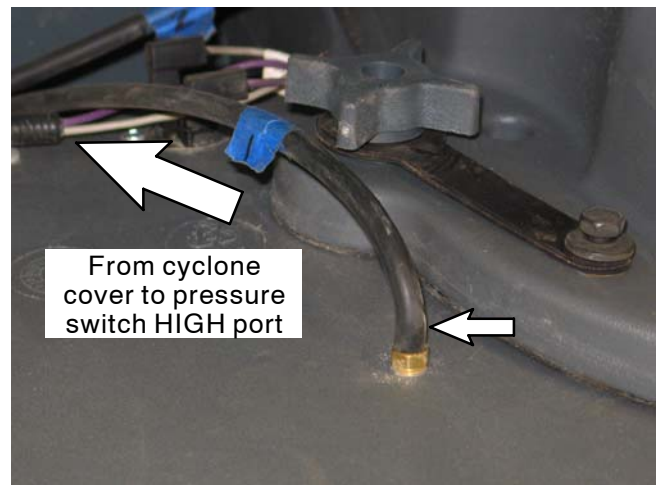
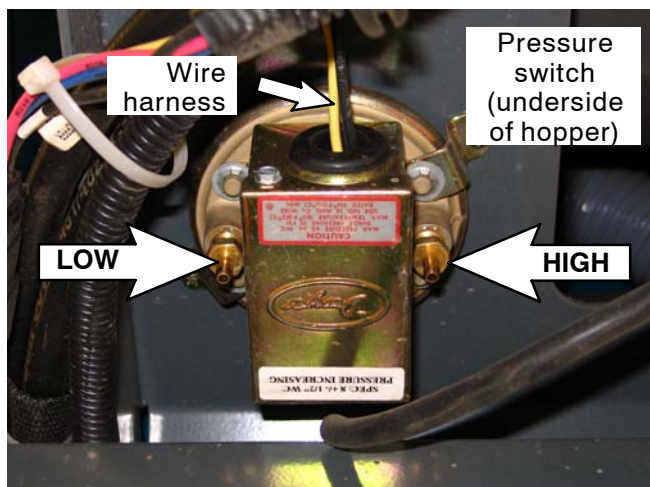
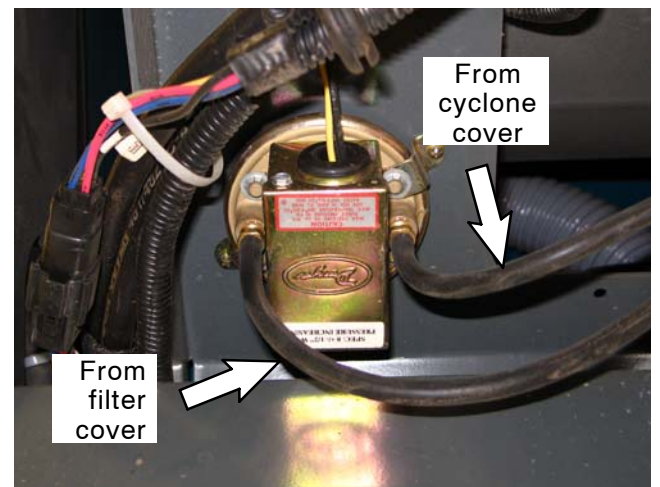
**NOTES:** The hose from the filter cover should be connected to the LOW port on the pressure switch. The hose from the cyclone cover should be connected to the HIGH port on the pressure switch. Refer to photos below.

**PURPOSE:** Inspect hoses and move incorrectly installed hoses to the correct ports on the pressure switch.

Test the system: With the key on, remove the hose from the filter cover and apply a slight vacuum. The light will illuminate and the alarm will sound if the hoses are connected to the correct locations on the pressure switch.
